Manhole Inspection Summary

Manhole # S11QQ1027MH

Location Address: **4849 OAKLEY AVE**

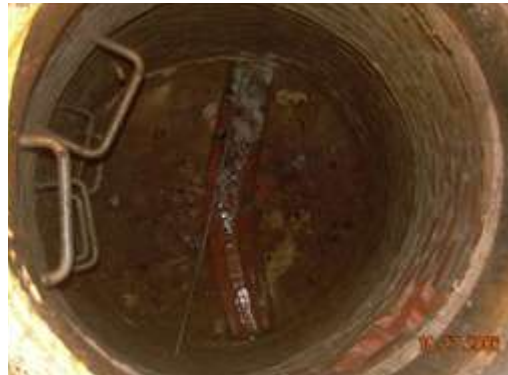
Top View

Adjustment, Corbel, and Barrel infiltration.
Bench debris. Channel debris

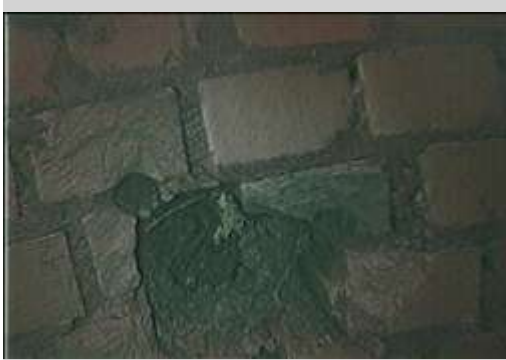
Defect

Condition: ☐ Sound ☒ **Cracked** ☐ Root Intrusion ☐ Loose Brick ☒ **Deteriorated**

Infiltration: ☐ None ☐ Joint ☒ **Cracks** ☐ Mortar ☐ Roots ☒ **Wall**

Hole in Corbel. Corbel infiltration.

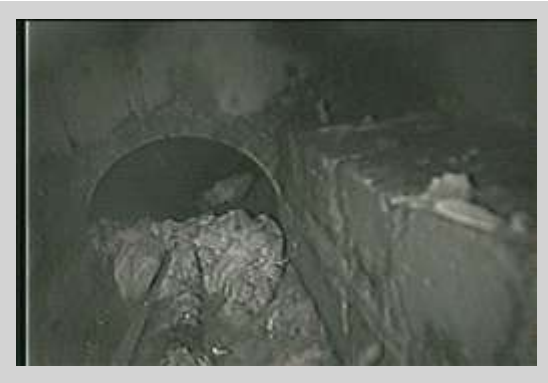
Pipe Out @ 12 O'Clock

Deposits: ☐ None ☐ Mud ☐ Sludge ☒ **Debris** ☐ Grease

Silt Depth: **3** (in.) Deposits Extent: **Medium**

Infiltration: **Evidence** Pipe Seal Cond: **Unknown**

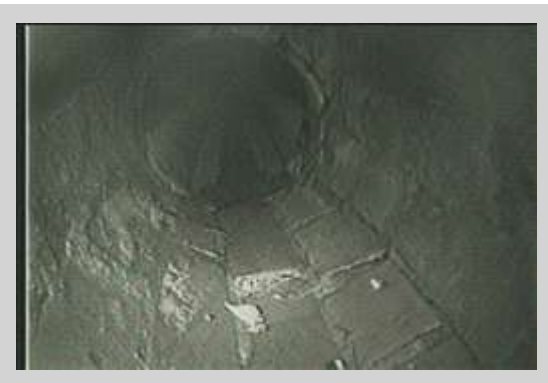
Pipe In @ 5 O'Clock

Infiltration: **Evidence** Pipe Seal Cond: **Cracked**
